Water Quality Assessment Report (Revision 2)

Miami River Basin

Miami, Florida

Wood Project # 6783-20-3235.04

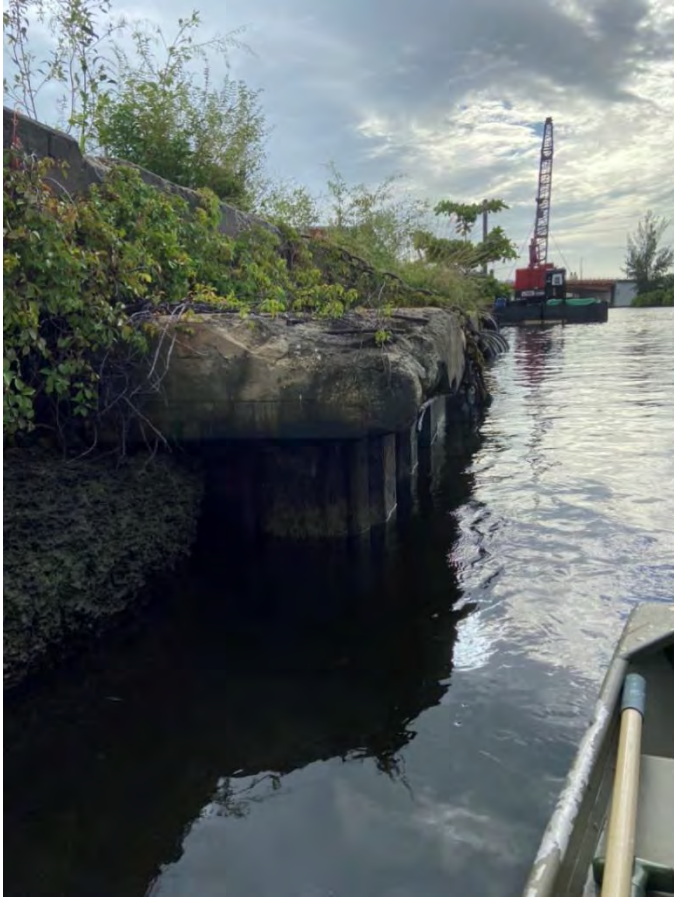
Photograph 1:
Sampling point: WB1
Station: MRSS1-1
Surface Water
10/22/20

- Observations: Thick foam/soapy appearance on surface of water. Pipes fully submerged. Very slight trash debris in MH. Sample area located near Gasolina Orion-gas station. Observed excessive trash and poor conditions to the south of the gas stations. Small flower market located to the east of the gas station property.

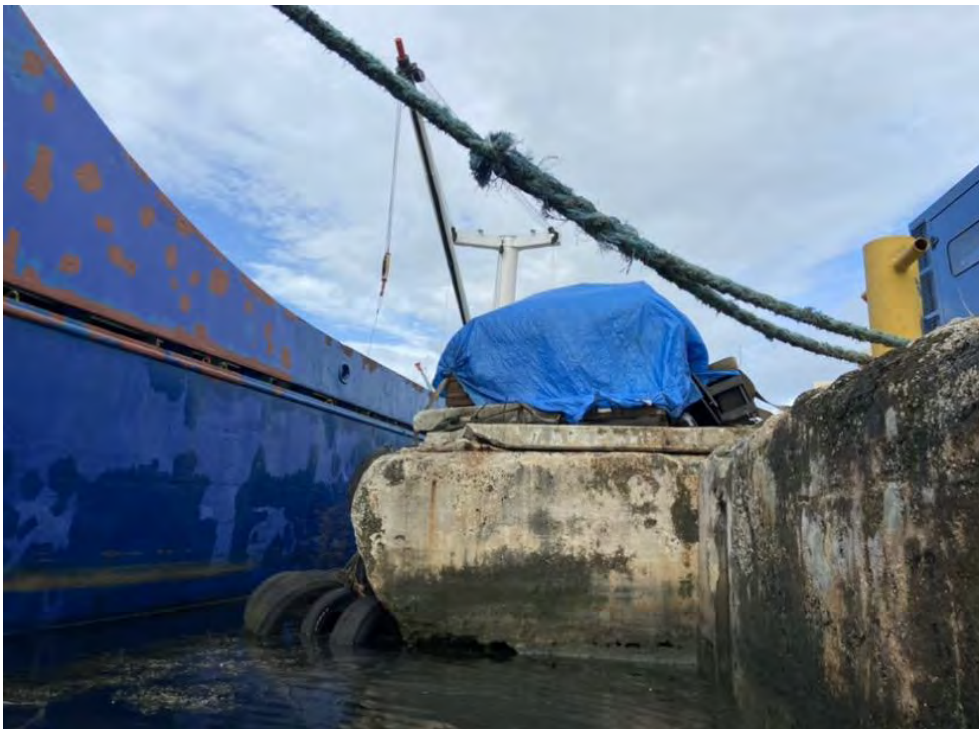
Photograph 6:
Sampling point: WB2
Station: MRSS1-3
Surface Water
10/22/20

3	WB2	MRSS1-3	Surface Water	County Outfall	534128	WB2 is a discharge point from a County major outfall along the northern edge of MR. It is south of NW North River Drive and it is slightly west of an approximate extension of NW 30 Avenue.	-80.244328	25.795704	-80.244326	25.795706	7.55	27.2	868	-138.1	36.1	2.87	2.81	Excessive oil sheen on surface of water. Large Cargo ship located directly to the south of the sample location. Smell of petroleum in vicinity NW of sample site. Observed Run Off from an adjoining property located approximately 0.3 miles upstream of sample site. Observed along north side of MR.	Pollution from vessels located in vicinity. Junkyard located to the north of the sample site.
4	M5	MRSS1-4	Manhole	County	534128	M5 is in the immediate south of NW North River Drive, and slightly east of NW 30 Avenue.	-80.243937	25.796185	-80.2439267	25.7961955	7.21	26.63	379	-56	33	2.66	8.63	of sampling. Excessive trash debris in MH. Five Star Complete Auto Paint located directly to the South. Metal	Trash debris. General vicinity appeared unkempt. MH within an industrial use area.

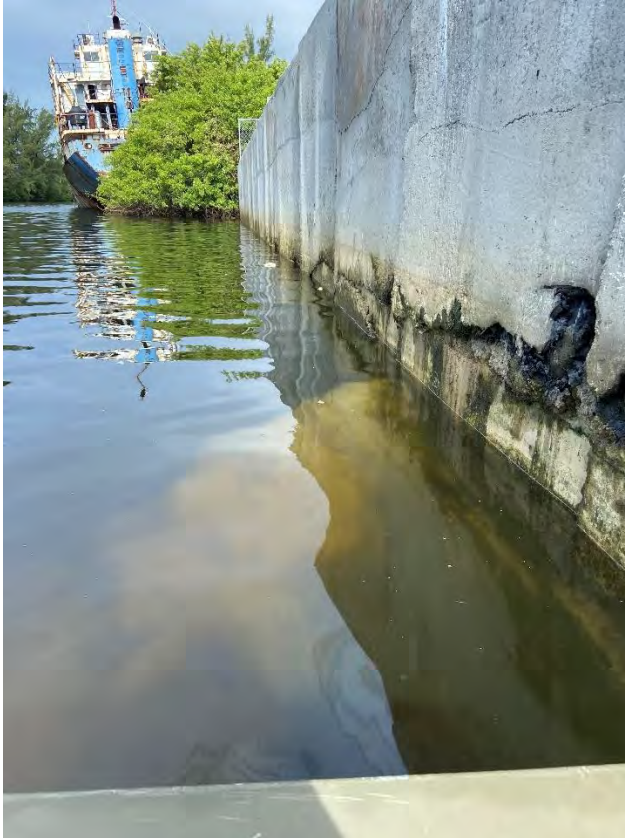
Photograph 15:
Sampling point: WB3
Station: MRSS1-5
Surface Water
10/22/20

5	WB3	MRSS1-5	Surface Water	County Outfall	534128	WB3 is a discharge point from a County major outfall on the northern edge of MR and south of NW North River Drive. It is west of NW 33 Avenue.	-80.251669	25.801227	-80.251792	25.801263	7.59	25.97	448	-45.6	33	2.68	2.9	Fully submerged outfall, submerged by approximately 2' of water. Cloudy white discharge coming out of outfall at time of sampling. Vessels in vicinity of sample area. Observed run off from the rear of a property located on the south side of MR approximately 370 feet from sample site. Property appeared to be Kings Brothers Metal Recycling, junkyard property.	Vessels in surrounding area. Unsolicited run off from nearby property located to the southwest of sample area. Appeared to be coming from a junkyard property in close proximity to Kings Brothers Metal Recycling.
6	C15	MRSS1-6	Catch Basin	County	534128	C15 is a Catch Basin (CB) located on the intersection of NW North River Drive and NW 27 Street on the northern side.	-80.249238	25.800528	-80.249226	25.800454	8.06	25.58	213	-31	52	4.3	15	Fully submerged pipes. Foamy substance on top of water. Slight trash debris. Scrap metal facility to the North, boat yard to the south. Unkempt surrounding area.	Unkempt surrounding area. Trash debris from adjoining properties.

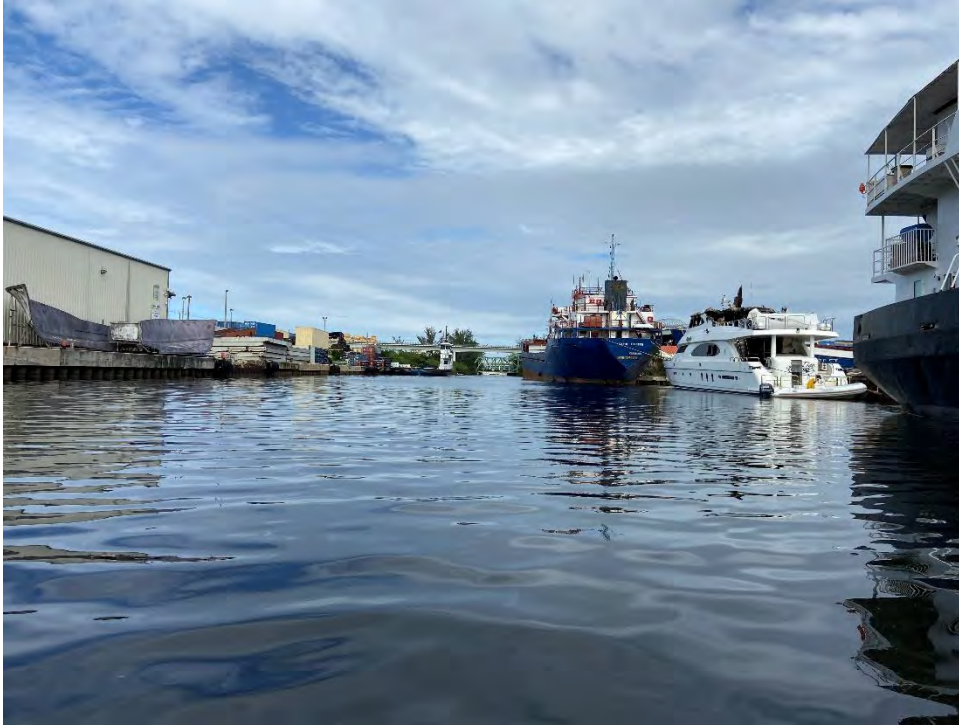
Photograph 21:
Sampling point: WB4
Station: MRSS1-9
Surface Water
10/22/20

9	WB4	MRSS1-9	Surface Water	County Outfall	534128	WB4 is a discharge point from a County outfall discharge point located along the south edge of MR and north of NW South River Drive. It is east of NW 28 Steet.	-80.256463	25.804199	-80.256463	25.804199	7.57	17.9	630	-116	17.9	1.42	2.25	Partially submerged outfall. Outfall submerged approximately halfway of the 3' discharge point. Algae was observed inside of the pipe. Surface of water appeared with small floating particles. Vessels in direct vicinity of sample area.	Vessels in surrounding area.
10	M2	MRSS1-10	Manhole	County	534128	M2 is located immediately north of NW South River Drive and south of MR. It is on the approximate extension of NW 37 Avenue from the north. There is a MH M3, northwest of this MH. M3 is the beginning of a County outfall.	-80.256628	25.803766	-80.2566085	25.803763	7.16	27.41	471	-63.9	21.4	1.69	8.23	Pipe direction appeared going to the south and west direction. Water flowing south. Slight organic odor. Bricks and concrete debris observed. Water clear, bottom of structure visible. Observed a water hose discharging from BettyK Liner property, visible floody in surrounding area.	No obvious sources of contaminants, except for Betty K Liner discharging water from property.
