RER-DERM SmartCover Pilot Study

Galo Pacheco, M.Sc., P.E. Interim Chief, Water and Wastewater Division

Monday, January 6th, 2025

RER-DERM Efforts to Eliminate Septic Systems Impacting the Miami River and Tributaries

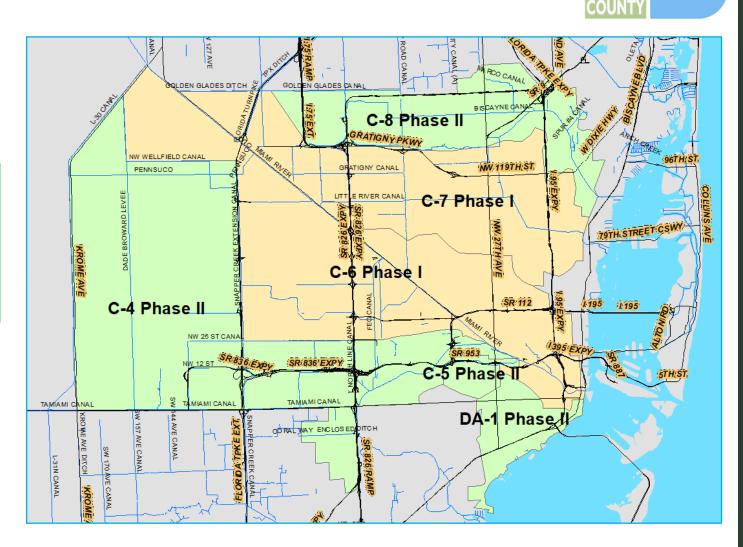
Total Units installed: 426

- Units Installed under Phase I: 192 (May 2023)
- Units Installed in Phase II: 234 (October 2024)

Utilities	Units Quantity (PH1)	Units Quantity (PH2)
Bay Harbour Island	1	
Opa-Locka	4	5
CNM	6	11
Hialeah Gardens	20	
Medley	33	
WASD	128	218
Total	192	234

- Criteria: Key manholes and pump stations, Historical SSOs, Citizen complaints, Sanitary Sewer Basin Moratoria.
- Real-time collection system monitoring, reporting and spill prevention
- Analysis of Inflow & Infiltration (I&I)
- Participating utilities receive the alarms and have access to dashboard

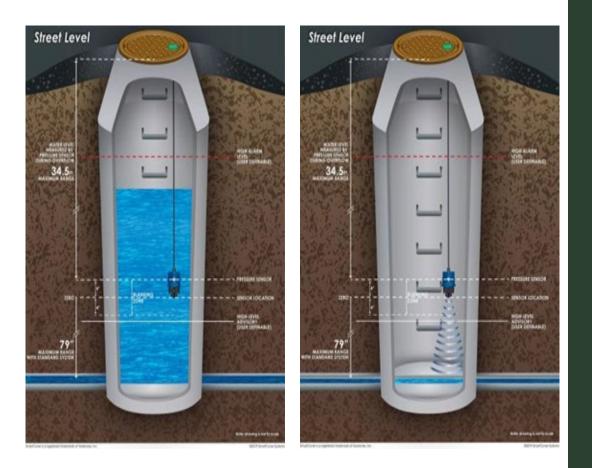
SUBSONIC DUAL SENSOR

- Highest accuracy on narrow inverts
- Drop lowest & closest to the channel
- Reliable during surcharges

- Real-time trend analysis
- Satellite communications impervious to power or cell outages
- No confined space entry
- Low maintenance

Ideal for remote locations Integration with rain, river, tidal data

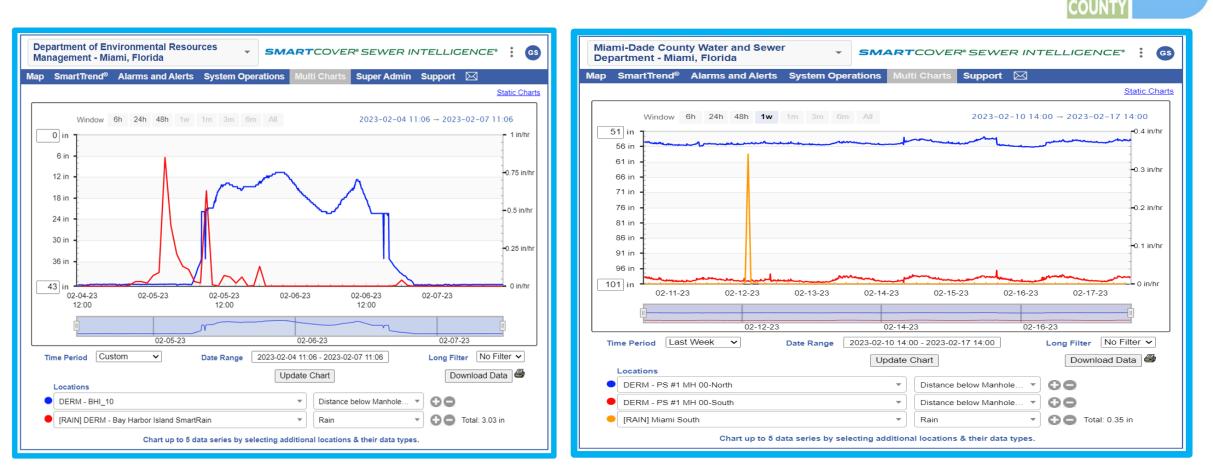
I/I Impact

- Identify, in priority order, the SmartCover sites at high risk for significant I/I
- Utilize time series data from the SmartCover site and the closest SmartRain to calculate a cross-correlation score (Pearson Coefficient)

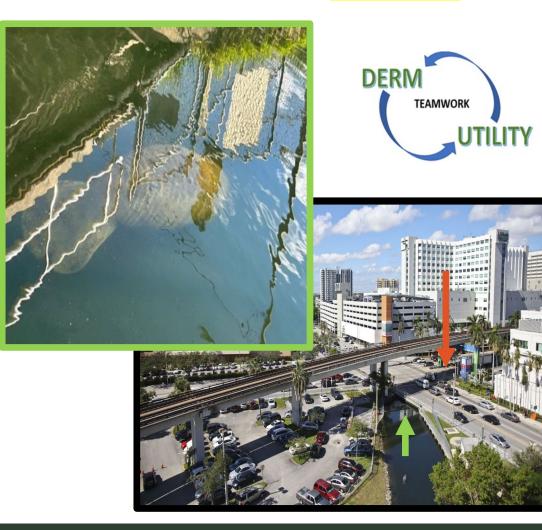
Preventing SSOs, Contamination of Surface Waters and Protecting Wildlife

- Previous SSOs in the corner of NW 14 ST and NW 12 AVE
- > DERM W&WWD and WASD team coordinated the installation of a SmartCover
- Prevented a significant SSO into Wagner Creek!

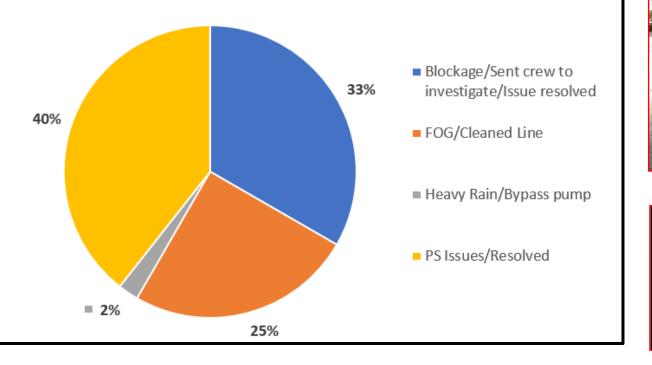
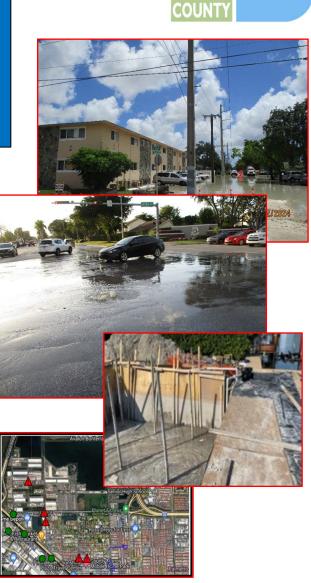
> Prevented SSOs by Cause and Actions Taken Phase I & 2

The RER-DERM SmartCover Pilot Study has helped to PREVENT 150 SSOs from January 2023 to October 2024

99 PREVENTED SSOs during Phase 1 (January 2023 – March 2024) 51 PREVENTED SSOs during Phase 2 (April 2024- October 2024)
